# **PLAINTIFFS' SUMMARY JUDGMENT OPPOSITION**

## **EXHIBIT A-21**

RE: Purported Notice with Respect to Termination of the Ludington Pumped Storage Plant EPC Contract dated October 15, 2010, as amended (the "Contract")

1. Structure of DRE
2. Requirements for DRE
3. Current DRE Situation
  - 3.1 Inspection Acceptance Criteria During Operation
  - 3.2 Condition of Each DRE (PT indications)
  - 3.3 Corrosion situation by Unit
  - 3.4 Cause
    - 3.4.1 DRE NDE PT Indications
    - 3.4.2 Corrosion of Unit 2 and Unit 4 legacy parking ledges
4. Toshiba Proposal
  - 4.1 Toshiba's proposal
  - 4.2 Unit2 and Unit4 Legacy Parking Ledge Repair Procedure

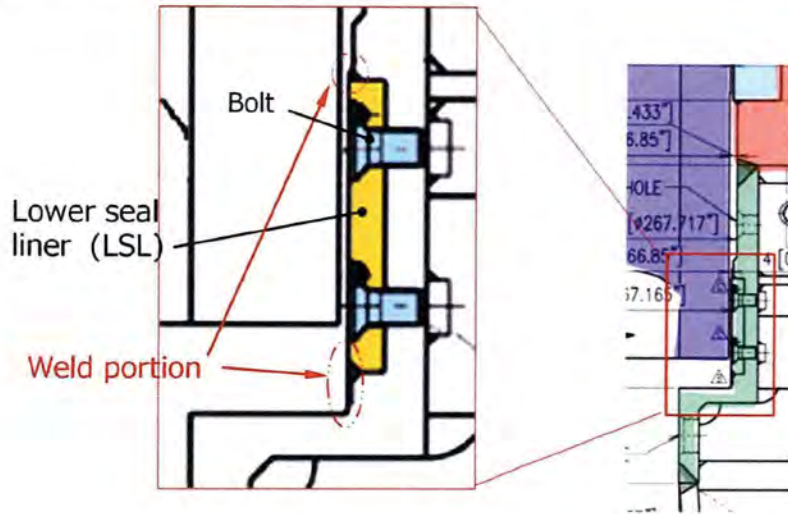
## g) Gap between lower seal liner and DRE visible –

The inner diameter of the DRE is final machined in the field after installation, but there are variations in the amount of material removed circumferentially due to the DRE installation tolerance before machining. Therefore, those portions with larger amount of material removal during final machining are the areas where the weld thickness of the LSL to DRE seal weld becomes reduced. Cracks develop in the thinner seal weld areas and a small gap between LSL and DRE becomes visible. As explained in f), it is an auxiliary weld and Toshiba's design concept does not require repair. Also, repair is not required because there is no water leakage to the outside.

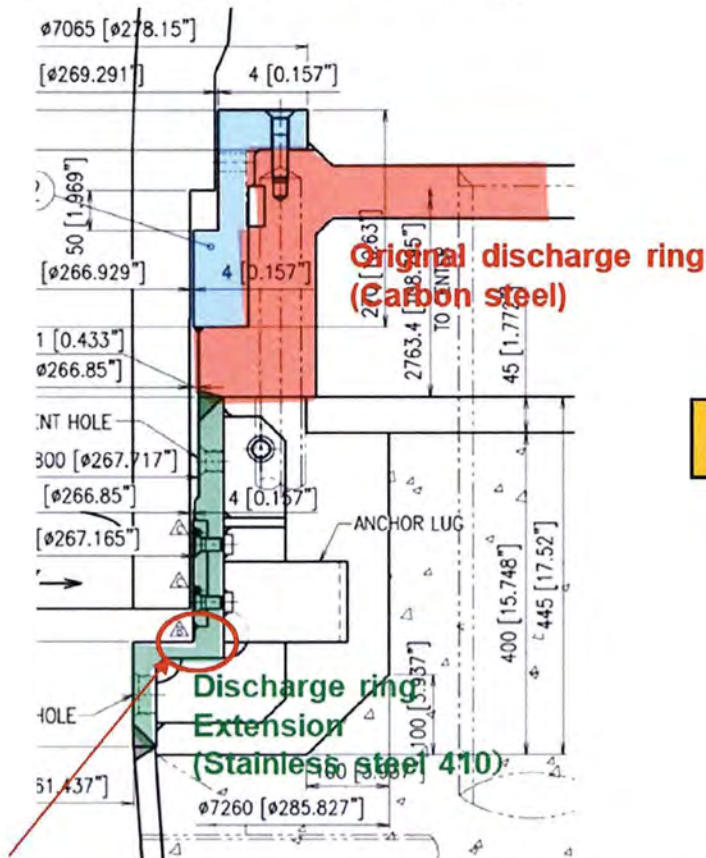
Initial structure  
(same as units 6 and 1)

Indications(cracks) occur in the Parking ledge corner during installation. The repair was repeated, but it was rejected.

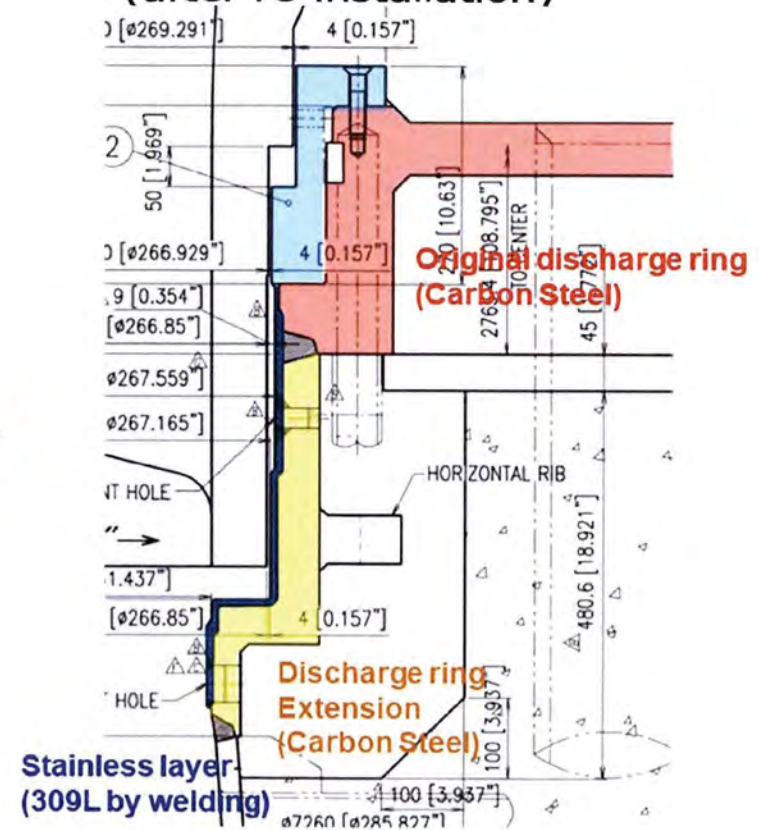
Final Structure  
(after re-installation)

The material and structure were changed and re-installed.

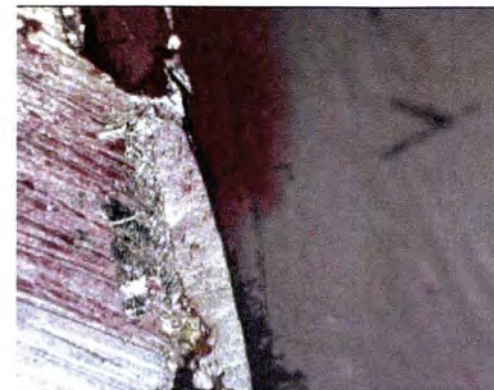
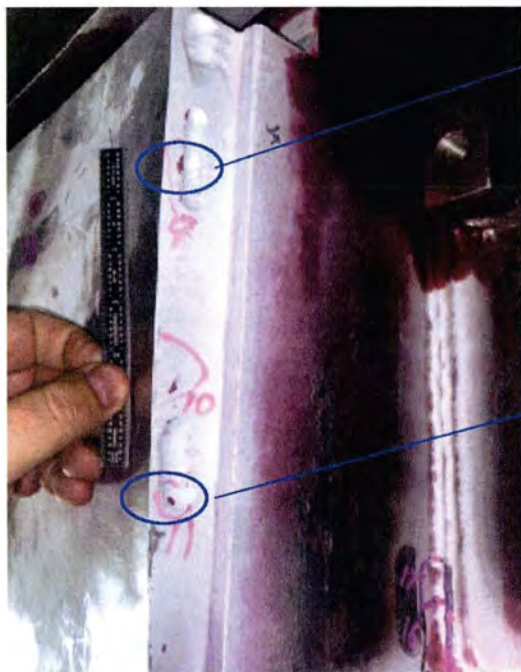
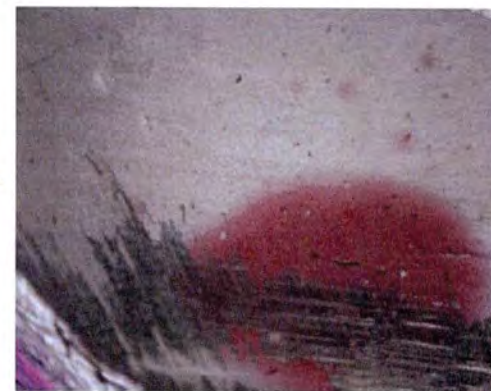
Observation with microscope

**Rounded indication**

A inclusion of the material was exposed due to wear at the previous repair portion.  
Not progressive

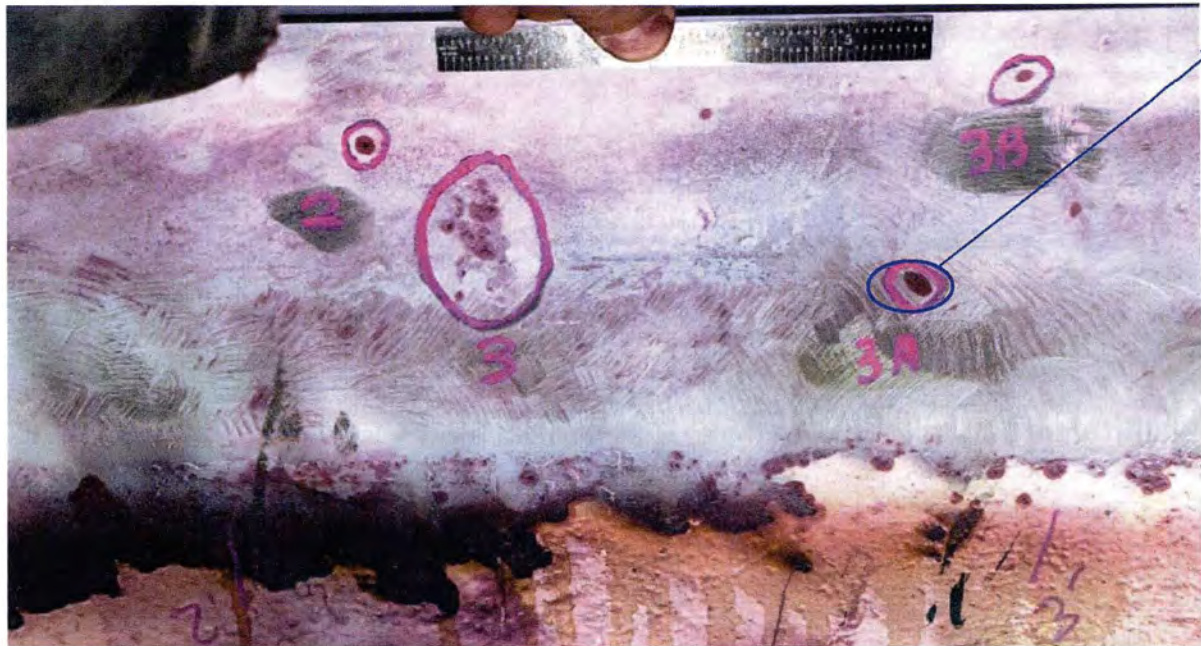
# Sample A-3

**Rounded indication:** minor unmelted portion of weld

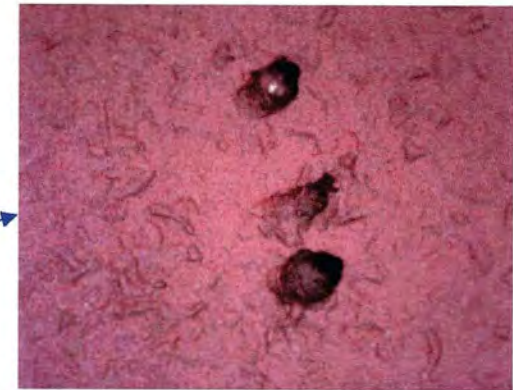
Rounded indication  
 A minor blow hole of weld  
 was exposed due to wear.  
 Not progressive

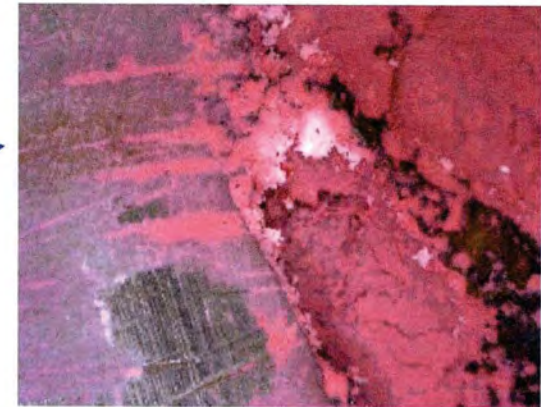
## Linear indication

A inclusion of material was exposed due to wear.  
Not progressive

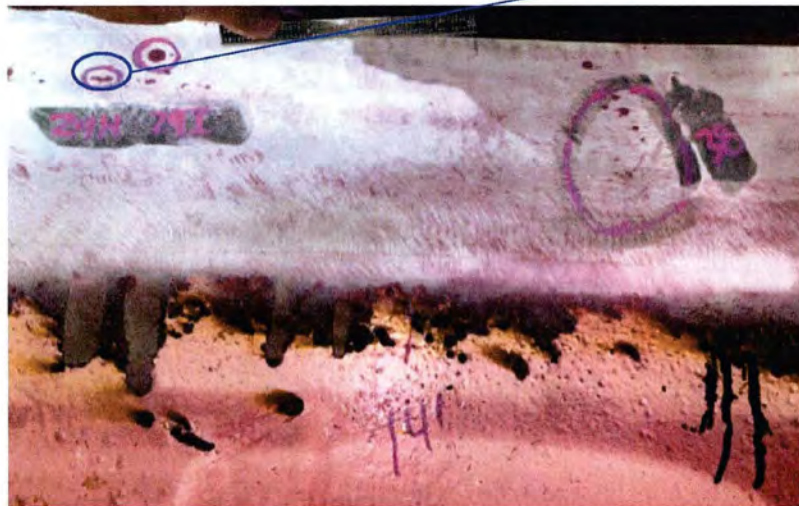
## Linear indication

A minor unmelted portion of weld was exposed due to wear.

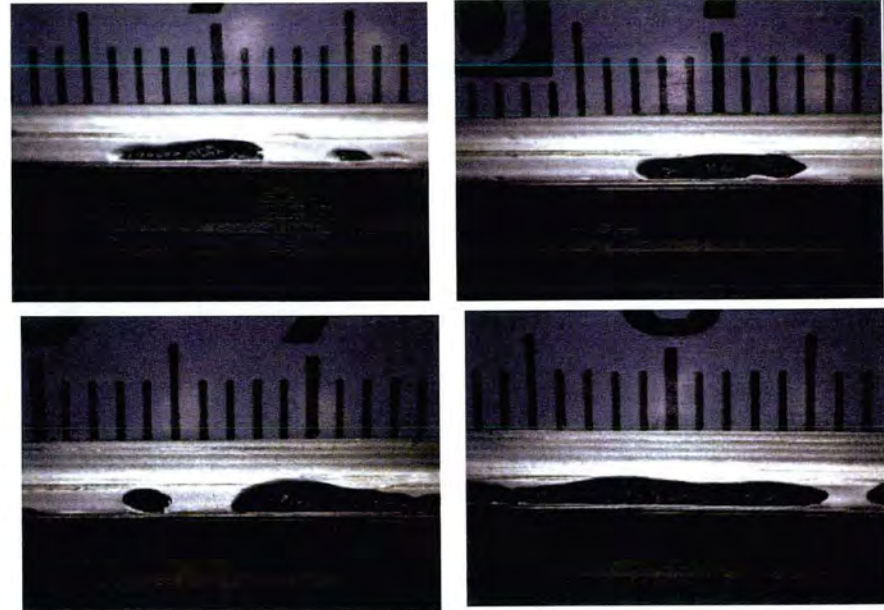
Linear indication  
Ummelted portion of the weld  
below the lower seal liner.  
There flaws do not impair the basic  
DRE requirement.  
No need to repair

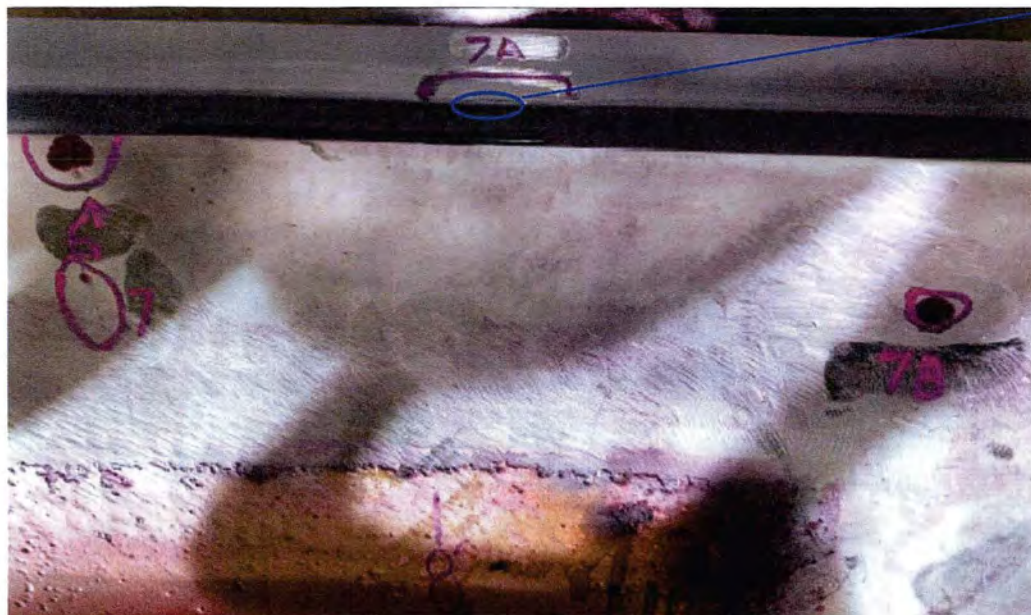
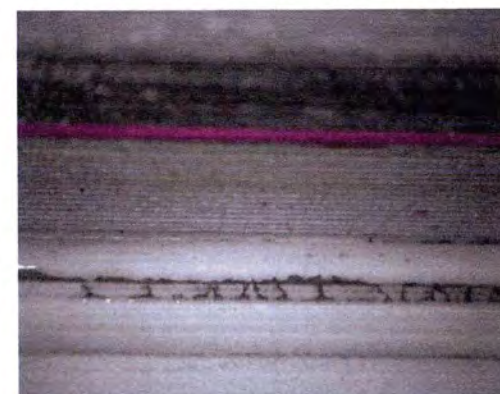
Inspection: Unit 2 Apr. 2022

Item ID Number	Location	Feet around	Type	Size	Evaluation	Outage	Remarks
7A	*	8	Linear	2.0"	REJECT	2022	Upper Vertical Plate

## Linear indication

No obvious defect was found by the observation with microscope.

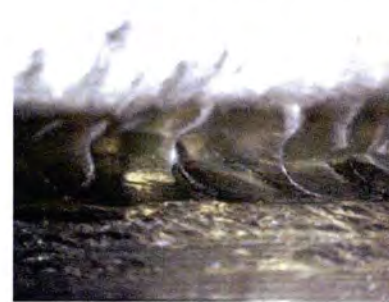
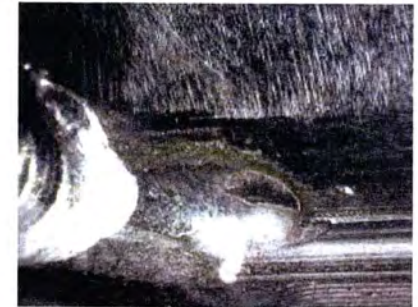
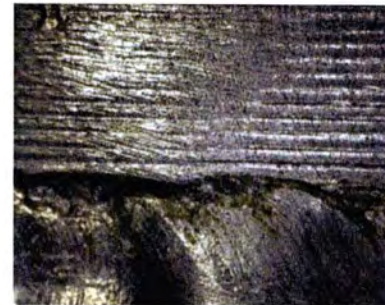
Linear indication

No obvious defect was found by the observation with microscope.

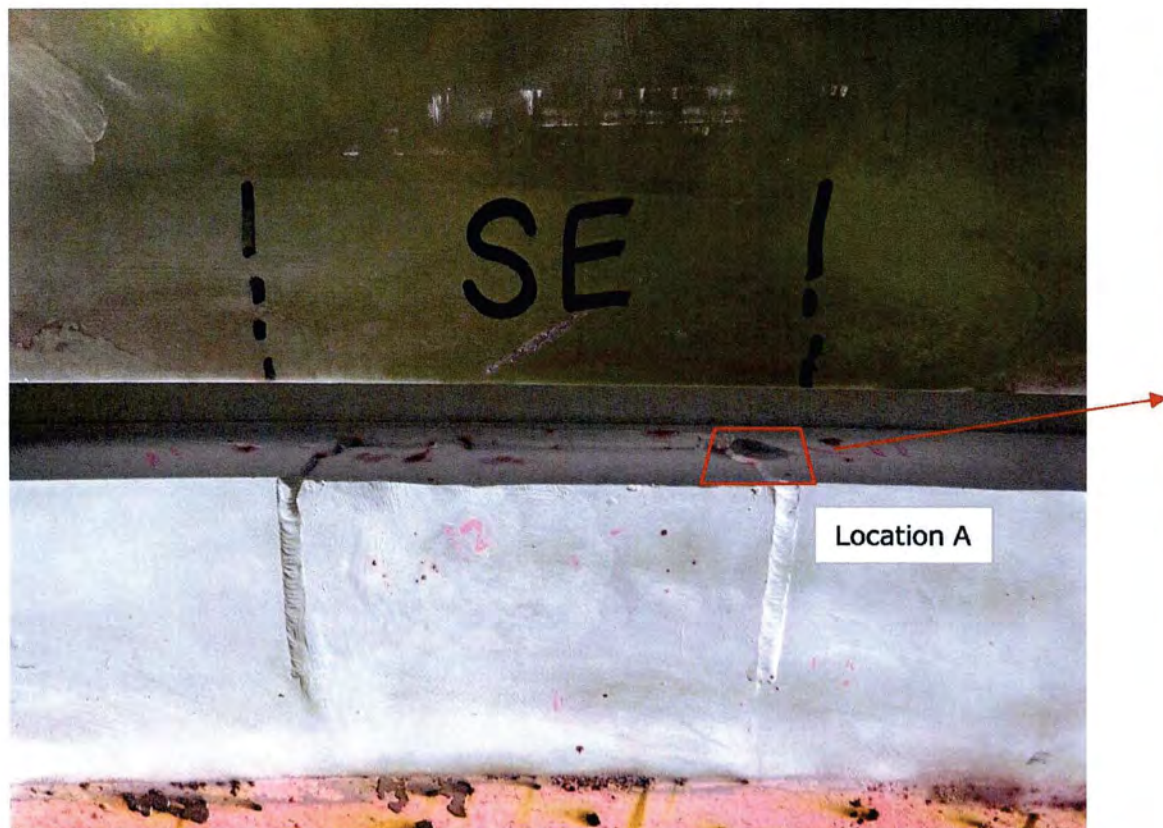
Pocket "SE"

## Unit 5 DRE water bleeding from pocket cover

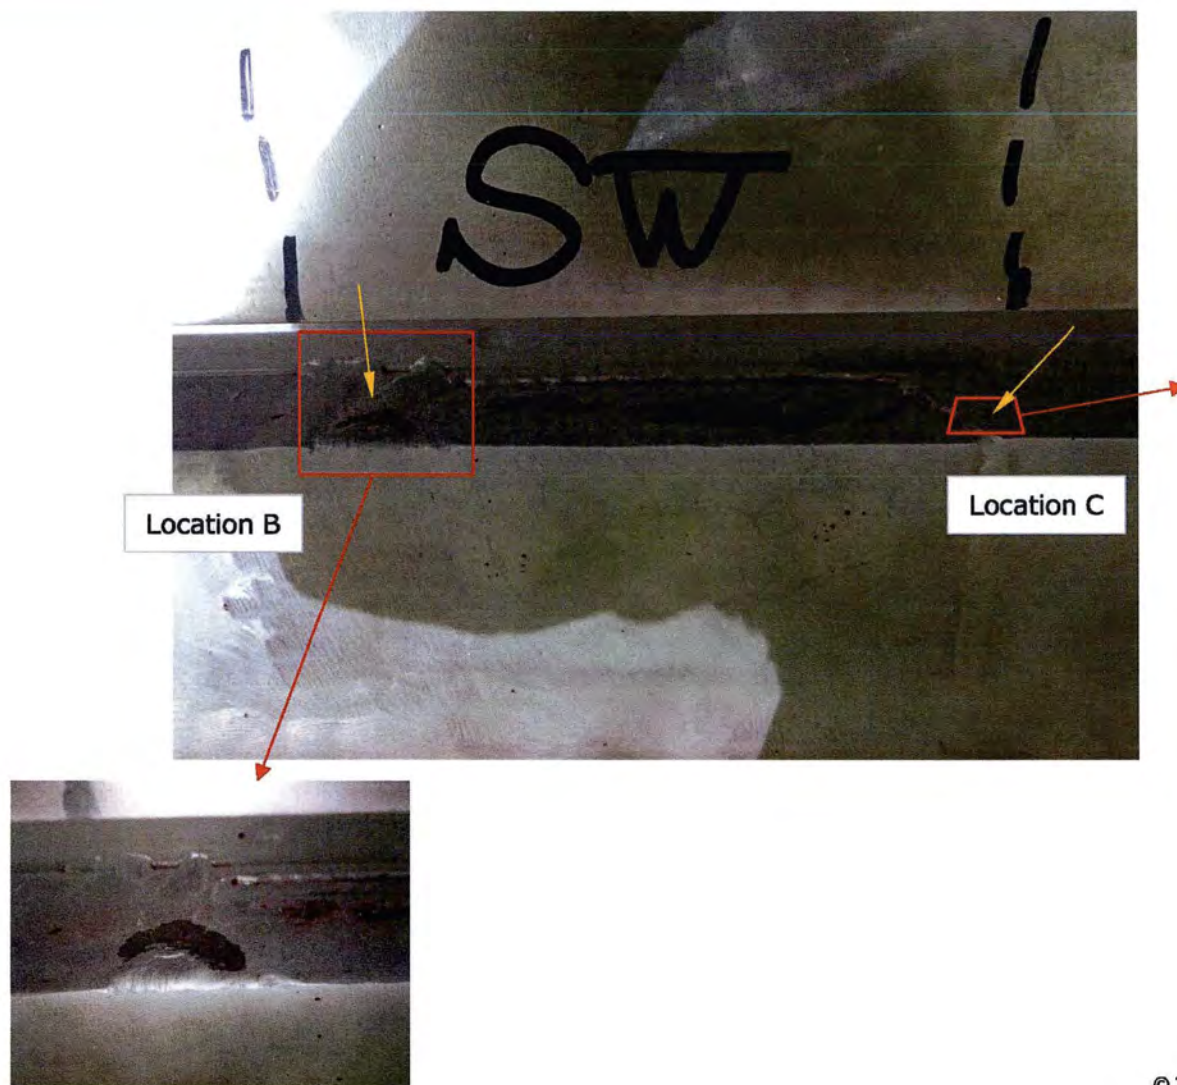
Pocket "SW"

## Unit 5 DRE water bleeding from pocket cover

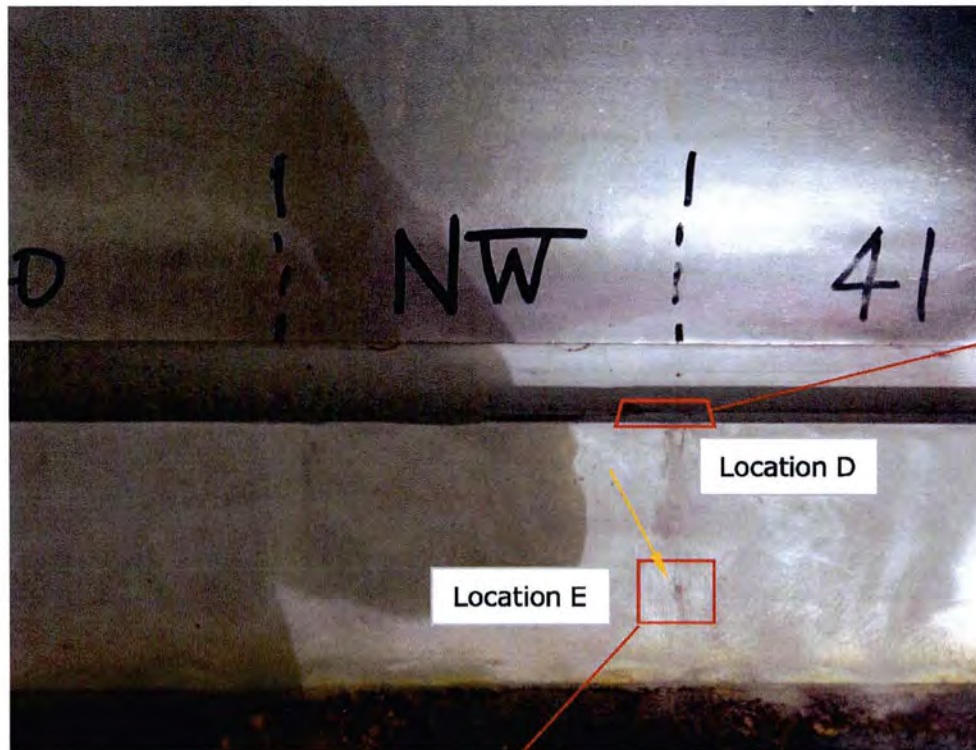
### Pocket "NW"

## Unit 5 DRE water bleeding from pocket cover

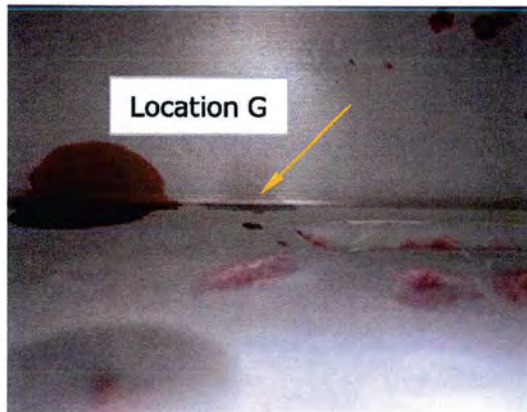
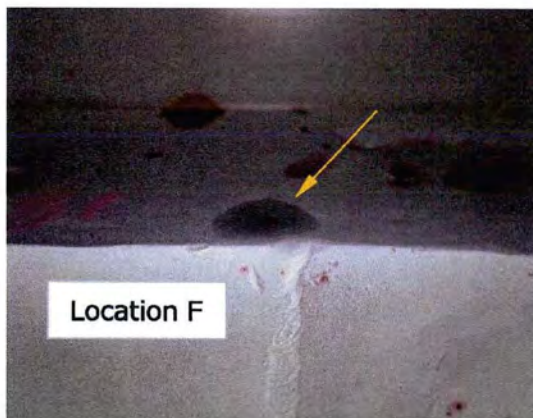
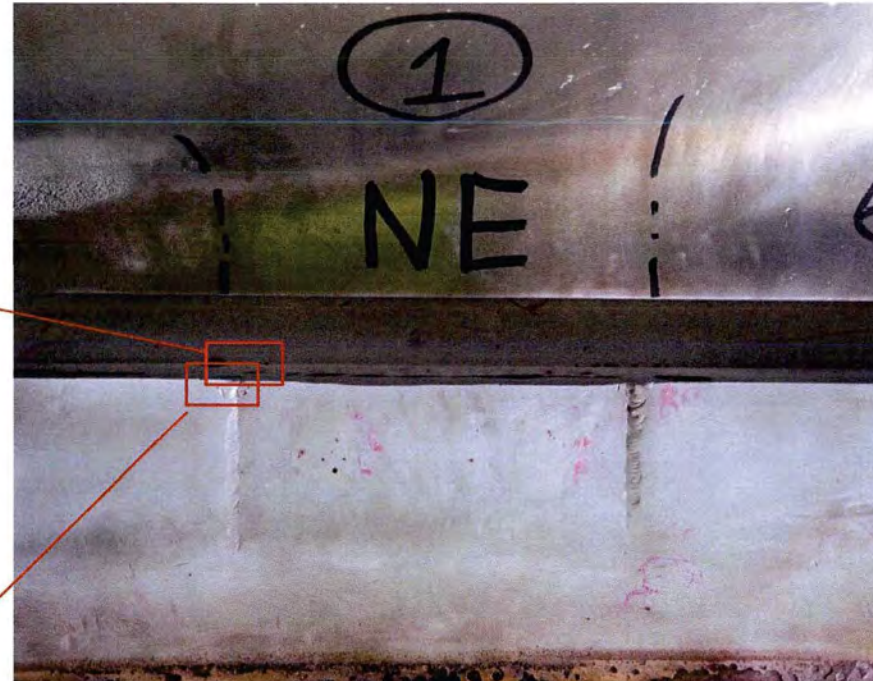
### Pocket "NE"

## Unit 5 DRE water bleeding from pocket cover

Most of the fillet welds were removed when machining after installation. Thin weld portion was penetrated due to wear and tear during the operation.

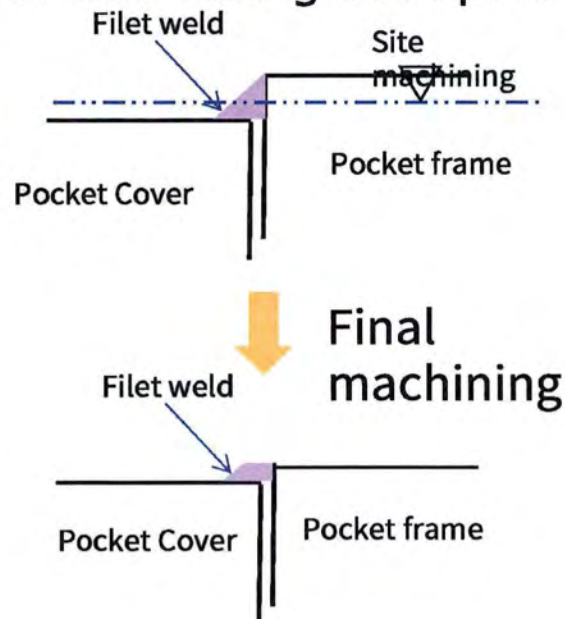
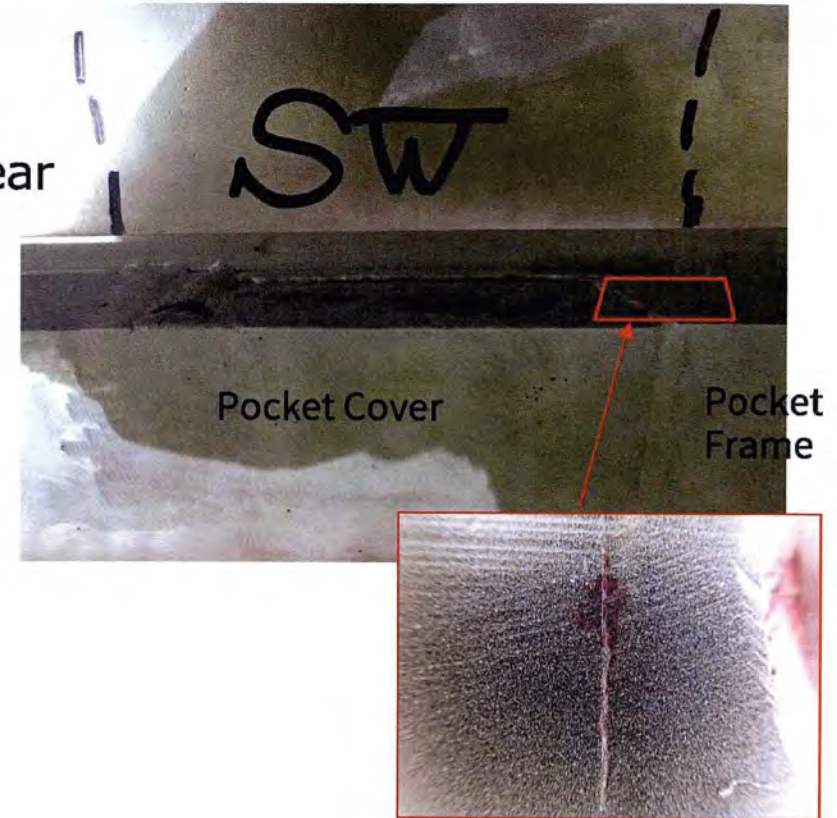
Water bleeding  
(View from the  
top)

U5 DRE NDE inspections were performed in May 2022 and revealed small indications of water leakage in the area of pocket cover factory welds. The presumed root cause is that final field machining of DRE resulted in material removal of pocket cover factory weld thickness resulting in water leakage. No other indications from May 2022 U5 NDE inspection required repair based on ECSK2020H0203 criteria. CEC postponed U5 DRE pocket cover weld repairs until October 2022 at which time Toshiba successfully completed those repairs. U5 DRE NDE inspections were performed

### Repair of water bleeding portion

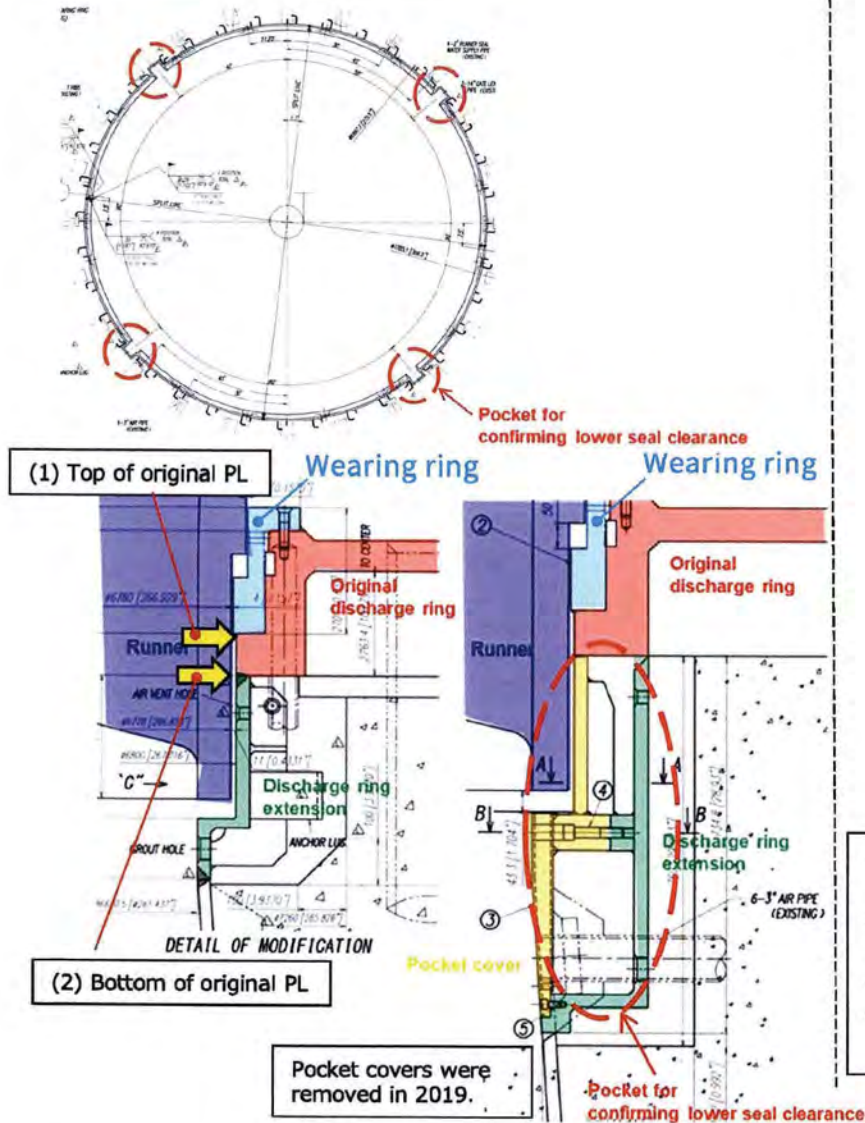
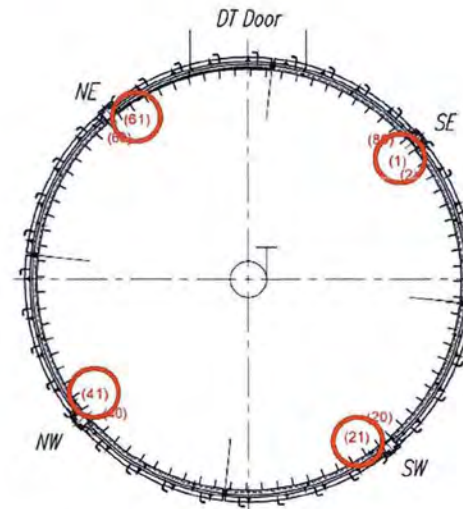
## Unit 2 (1<sup>st</sup> unit)

A follow-up inspection was performed during the April 2022 MTB outage. Maximum corrosion depth of 19 mm was measured at 3 runner gap inspection pockets. Semi-circular corrosion was also observed at fillet weld of the new wearing ring-to-legacy parking ledge. No Sabi-Shut remained on

Pocket Cover	Depth around lower part of the original PL corrosion (mm)
SE (1)	16
SW (21)	13
NW (41)	3-4
NE (61)	19

- The original PL (parking ledge) was divided into 84 blocks with a circumference of 250 mm and the original PL condition was checked.
- In the lower end of the original PL, corrosion was confirmed around 3 of the 4 runner gap inspection windows. The maximum depth exceeds 20 mm.
- No additional paint in 2021 remains on the corroded area.
- The original PL near the fillet weld of wearing ring was corroded not only near the inspection pocket but also at multiple locations.

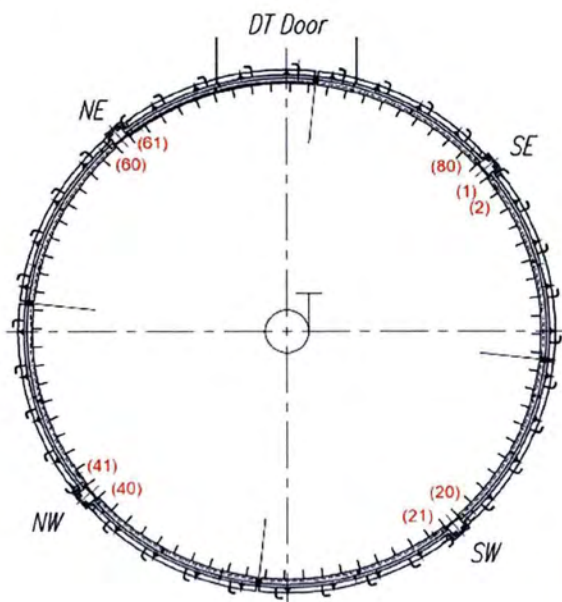
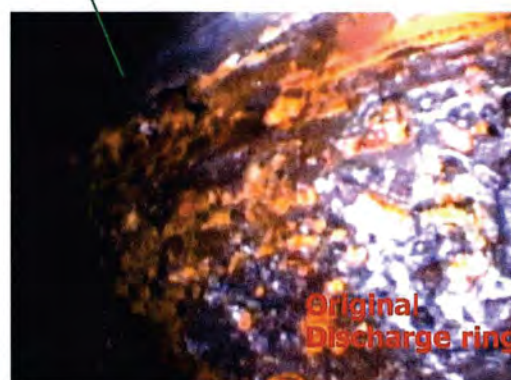
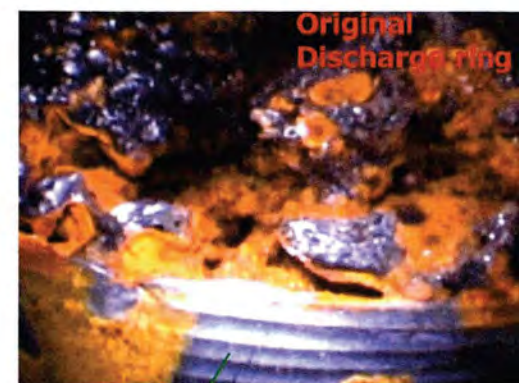
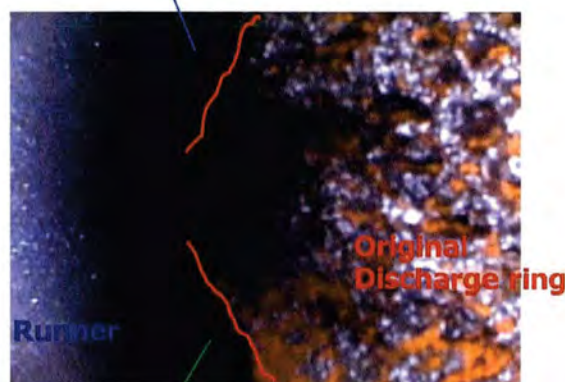
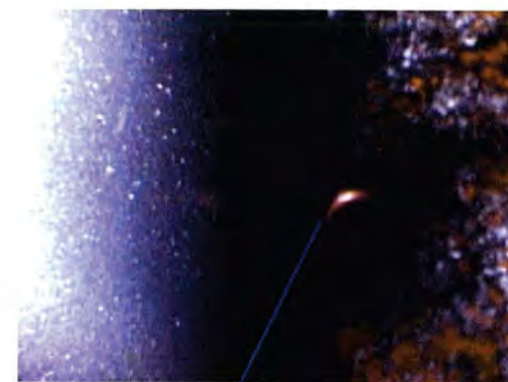
## Unit 2 (1<sup>st</sup> unit)

Pocket Cover	Depth around lower part of the original PL corrosion (mm)
SE (1)	16
SW (21)	13
NW (41)	3-4
NE (61)	19

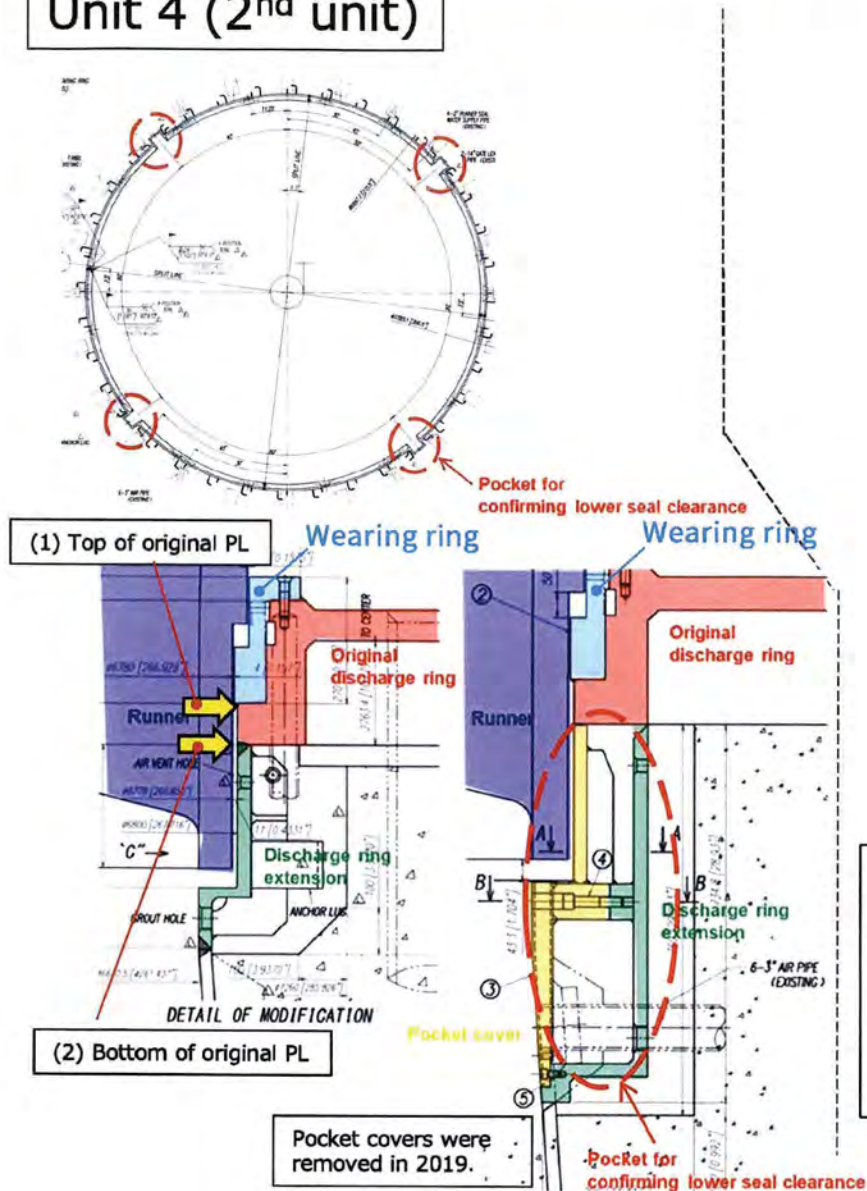
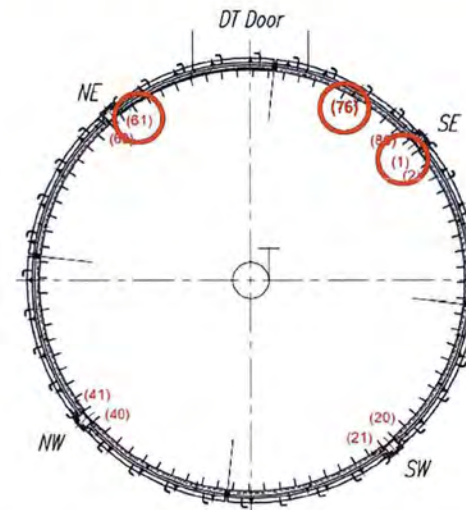
## Unit 4 (2<sup>nd</sup> unit)

A follow-up inspection was performed during the May 2022 MTB outage. Maximum corrosion depth exceeding 20 mm was measured at 3 runner gap inspection pockets. Corrosion was also observed at some locations between the runner gap inspection pockets and at the fillet weld of the new wearing ring-to-legacy parking ledge. No Sabi-Shut remained on the corroded areas of the legacy parking ledge.

Location	Depth around lower part of the original PL corrosion (mm)
1	20
61	20
76	15

- The original PL (parking ledge) was divided into 84 blocks with a circumference of 250 mm and the original PL condition was checked.
- In the lower end of the original PL, corrosion was confirmed around 3 of the 4 runner gap inspection windows. The maximum depth exceeds 20 mm.
- No additional paint in 2021 remains on the corroded area.
- The original PL near the wearing ring fillet was corroded not only near the inspection pocket but also at multiple locations.

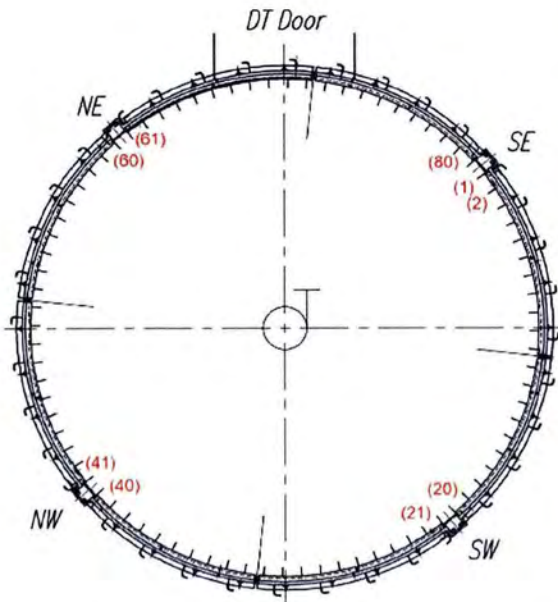
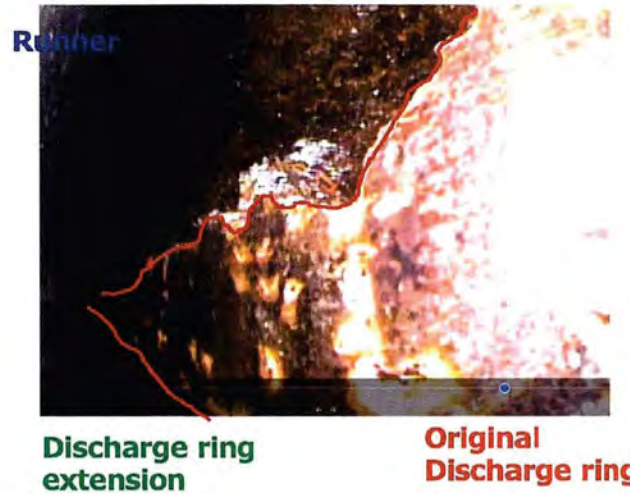
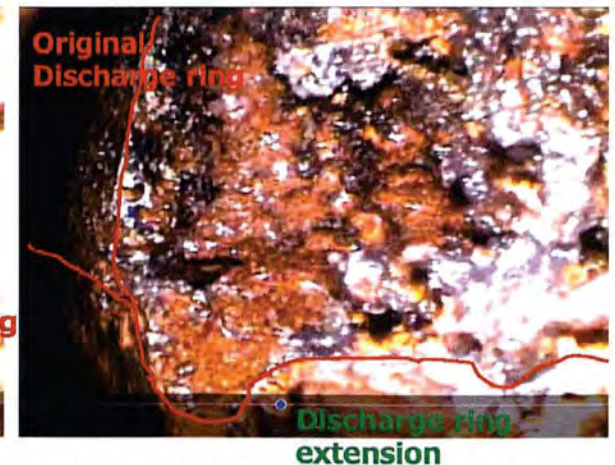
## Unit 4 (2<sup>nd</sup> unit)

Location	Lower part of the original PL corrosion depth measurement value (mm)
1	20
61	20
76	15

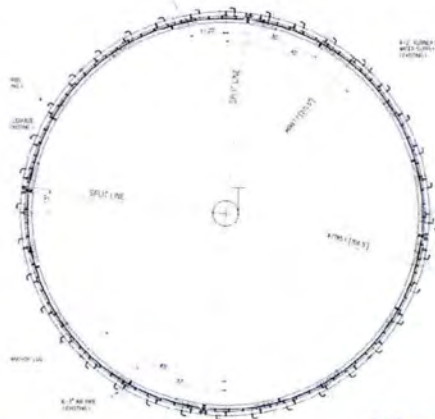
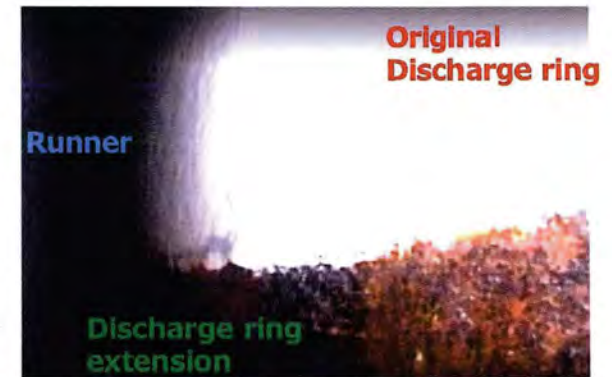
## Unit 5 (3<sup>rd</sup> unit)

- Painting remains on the surface of the existing PL almost all around.
- No significant corrosion is confirmed even in the part where the paint is peeled off.

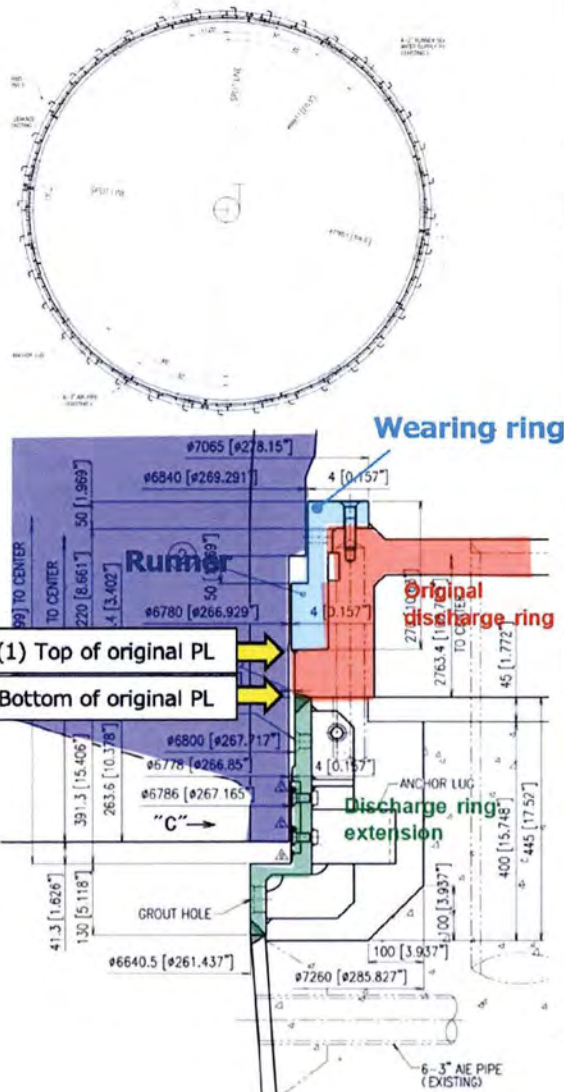
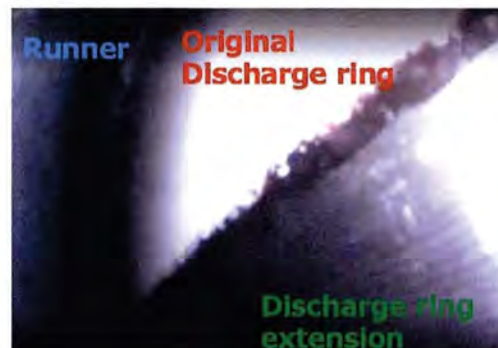
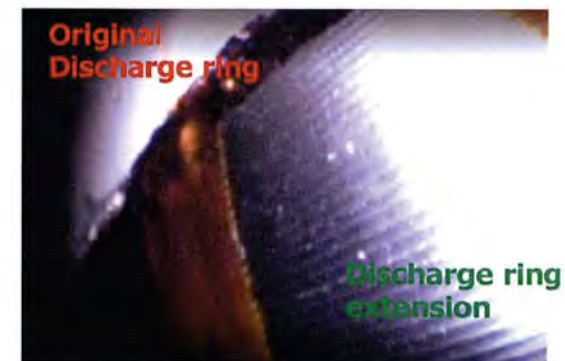
## Unit 6 (4<sup>th</sup> unit)

- Painting remains on the surface of the existing PL almost all around.
- No significant corrosion is confirmed even in the part where the paint is peeled off.

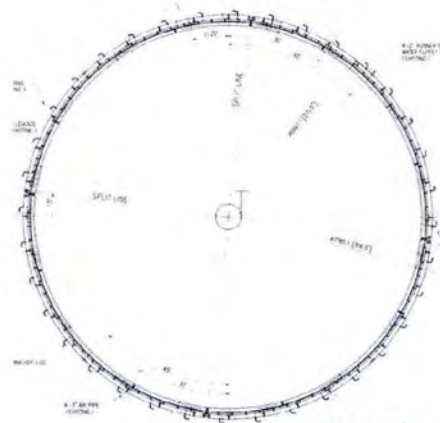
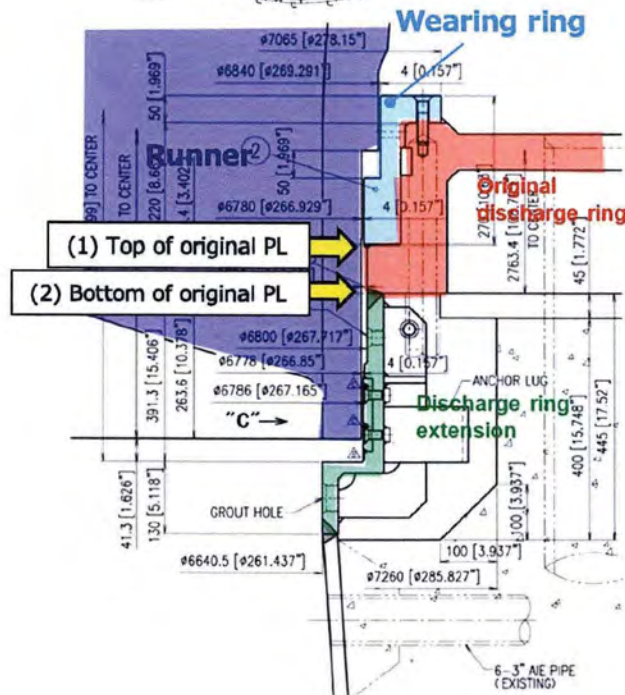
## Unit 1 (5<sup>th</sup> unit)

- Painting remains on the surface of the existing PL almost all around.
- No significant corrosion is confirmed even in the part where the paint is peeled off.
